GMC

Mid-March 2021, Volume 23, No. 6

## PROGRAMMING WITH THE Vehicle Intelligence Platform

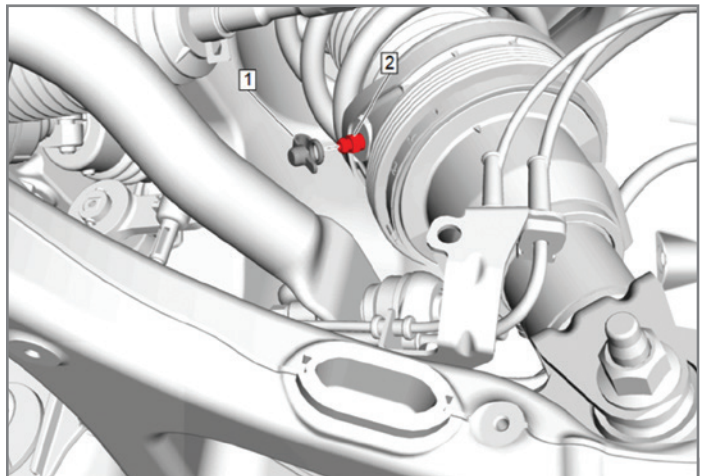
Front hydraulic suspension actuator bleeder valve

Test B covers performing the Prime Front Suspension Pump procedure using the scan tool if the DTCs reset. Perform the pump procedure five times in an attempt to purge any trapped air bubbles from the system.

Next, raise and lower the front suspension system through 10 complete cycles. If the DTCs reset, perform the Front Hydraulic Suspension Bleed procedure and reevaluate the concern. Any time the front hydraulic suspension system is opened, it's necessary to bleed the system at the front hydraulic suspension actuator bleeder valve using the CH-29532-A Pressure Brake Bleeder and CH-44894-A Brake Bleeder Adapter. Be sure to perform the bleed procedure before replacing any components.

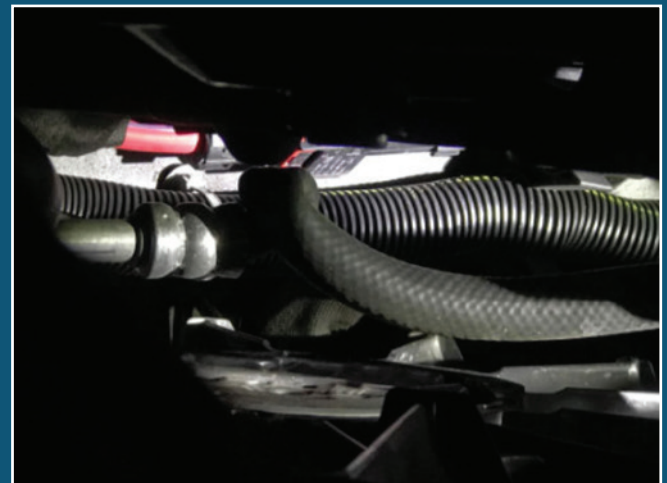
A harsh shift, shudder, surge or stall condition may be present on some 2021 Silverado, Tahoe, Suburban, Sierra, Yukon, and Escalade models equipped with the 6L80 or 6L90 6-speed automatic transmission (RPOs MYC, MYD), 8L90 8-speed automatic transmission (RPO MQE), or 10L80 or 10L1000 10-speed automatic transmission (RPOs MQC, MQB, MGM, MGU) and with low mileage. These conditions may be caused by a twisted transmission cooler line.

Example of twisted cooler line

If a twisted cooler line is found, disconnect the cooler line from the transmission auxiliary cooler and untwist it. Reconnect the cooler line if the rubber is not deformed or misshapen or there are not any other issues with the line. If the cooler line is damaged or deformed from being twisted, it should be replaced.

Check the transmission fluid level following the procedures in the appropriate Service Information and add fluid if needed.

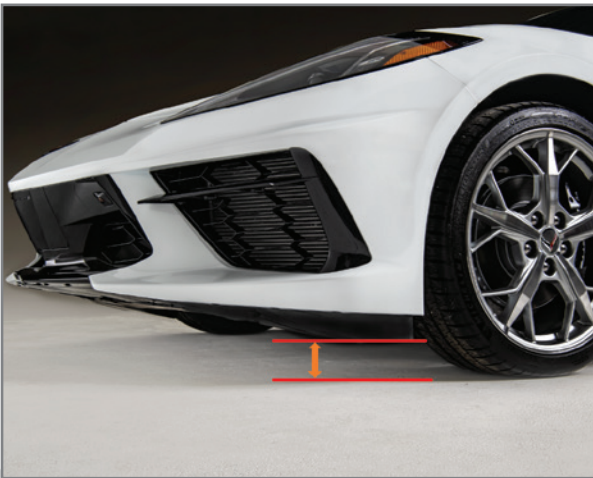
The vehicle should reach a front fascia height of at least 35 mm.

After bleeding the system, verify proper system operation by measuring the distance between the floor and the lower portion of the vehicle's front fascia. A correctly operating vehicle should reach a front fascia height of at least 35 mm within four seconds of pump operation.

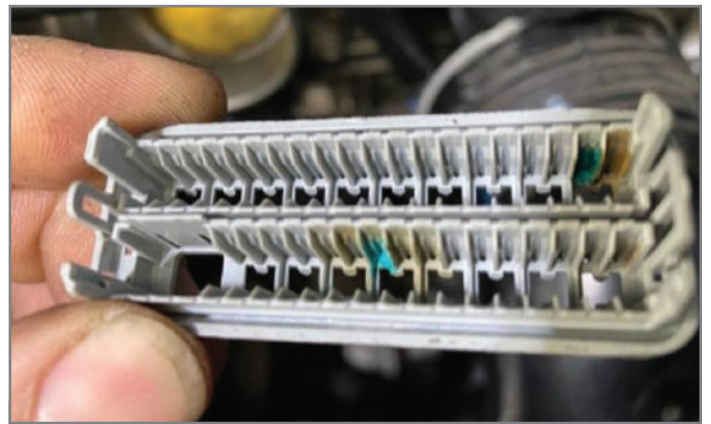
Use a bright light to inspect all the terminals in all three connectors for green corrosion, coolant or oil. Inspect all terminals regardless which DTCs may have set. Every terminal must be inspected since circuits that are corroded or contaminated can back feed into other circuits that are not corroded and set DTCs for associated systems.

Terminal guide removed from connector

Any terminal that has signs of green corrosion should be replaced with terminated leads. Do not clean the terminals. The contact area is difficult to clean and will lead to poor connections and intermittent DTCs. Solder all terminated leads and cover with

shrink tubing. Do not use crimp connectors to splice the circuits together.

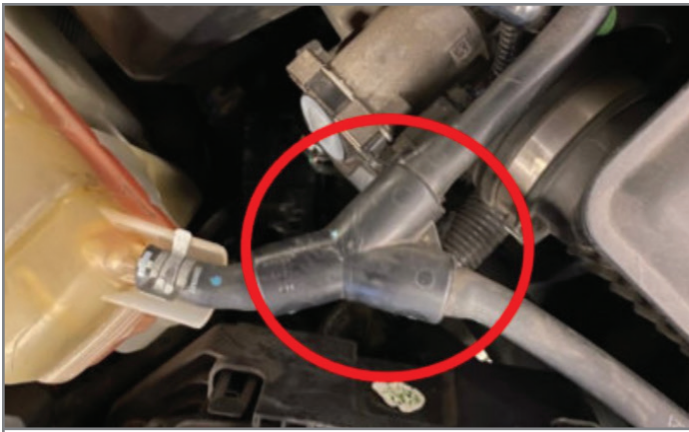
"Y" hose from coolant reservoir

If the coolant source is not from the coolant wicking up the engine coolant temperature circuits and into the ECM, inspect the coolant reservoir and "Y" hose located above the ECM for leaks. Replace the reservoir or "Y" hose as needed.

If the coolant was leaking down onto the ECM from the reservoir or "Y" hose, the ECM may have to be replaced, depending if coolant saturated the ECM and ECM sockets. Shake the ECM and listen for any coolant sloshing inside the ECM. Replace the ECM if coolant is heard inside the ECM. If coolant is only in the ECM socket, clean the ECM sockets with electrical contact cleaner and blow out with compressed air.

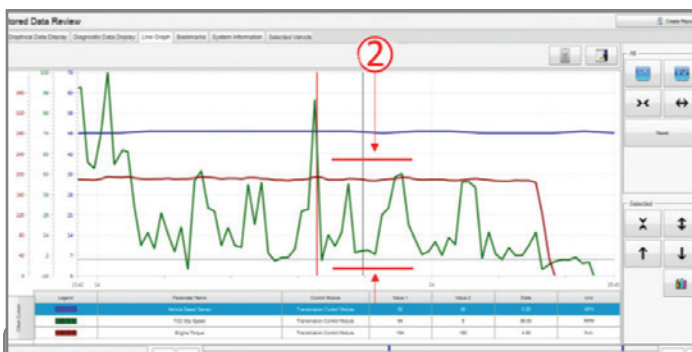
Degraded test result using GDS 2.

If the test results show a vehicle has a degraded TCC RPM slip at steady throttle or TCC shudder frequency at slight tip-in, the appropriate fluid exchange procedure should be completed using the DT-52263 Transmission Fluid Exchange Kit and the DT-45096 TransFlow Cooler Flush Machine.

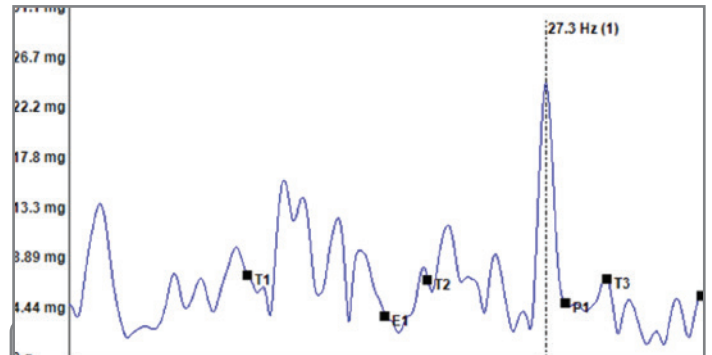
is present, a vibration peak (using the PicoScope) will appear. TCC shudder vibration frequency is stationary in 8th gear. If the vibration frequency follows vehicle speed or engine speed, then it is not TCC shudder.

Degraded frequency depicted in the PicoScope graph.

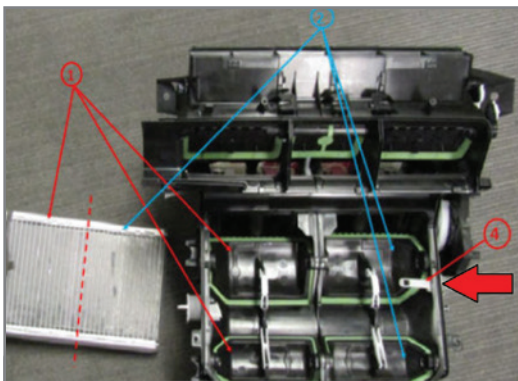
1. Two passenger-side temperature doors and heater core
2. Two driver-side temperature doors and heater core
4. EAT sensor location in relation to the driver-side temperature door.

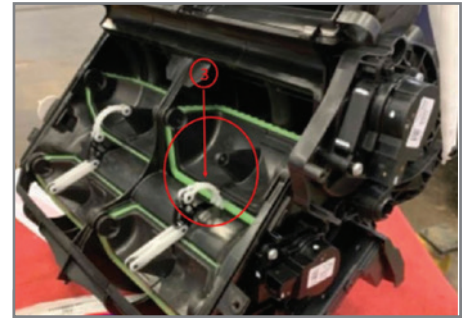
Inside the HVAC case, there are four white links that connect each of the four temperature doors. If one of these white links becomes disconnected, the doors will not operate properly.

There are four white links (#3) that connect each of the four temperature doors.

If a temperature door is not moving properly, there may be an issue with one of the white links that connect a temperature door, a temperature door issue, or an actuator issue. Follow the diagnostics in the appropriate Service Information to determine the root case. It may be necessary to disassemble the HVAC case to identify the source of a door issue and to replace any parts.

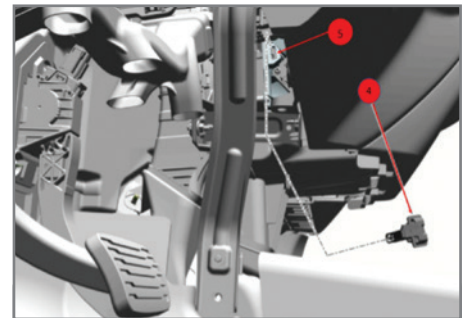
Use a bore scope through the opening (#5) for the EAT sensor (#4) to inspect both driver-side temperature doors.

Use a bore scope through the opening for the EAT sensor to inspect both driver-side temperature doors while changing the HVAC temperature setting from full cold to full hot, or manually rotate the driver-side temperature door shaft with the temperature actuator removed.
