GMC

Mid-March 2021, Volume 23, No. 6

## PROGRAMMING WITH THE Vehicle Intelligence Platform

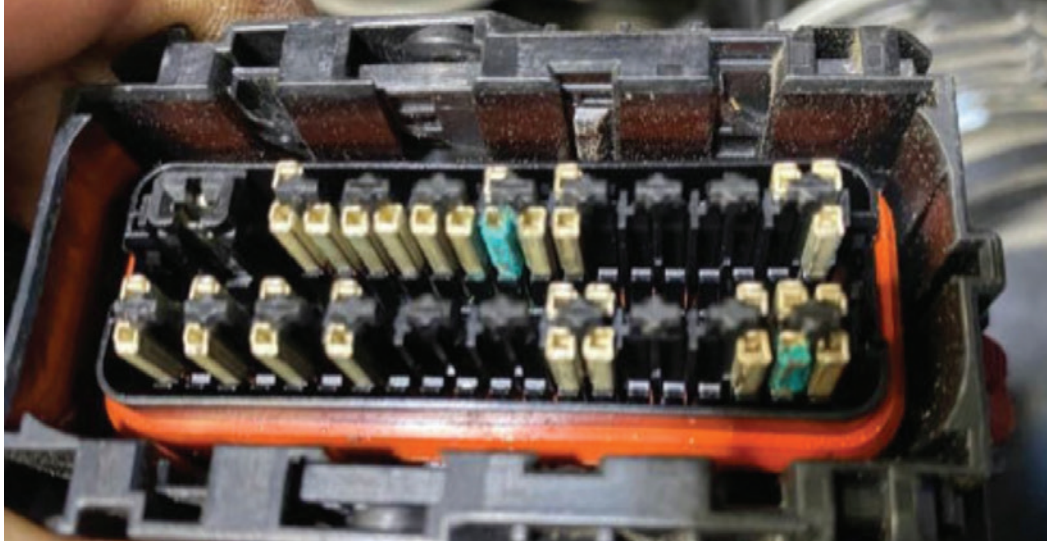
2013-2019 ATS models equipped with the 2.0L 4-cylinder engine (RPO LTG) or 2.5L 4-cylinder engine (RPO LCV) may have a crank, no start condition with an intermittent Check Engine MIL illuminated. Some of the following DTCs may be set: P0014, P0013, P0017, P0192, P0236, P0237, P0335, P0336, P0340, P0341, P0365, P0366, P0420, P0452, P0641, P2123, P2138, P2227, P2228, and/or P2618.

Use a bright light to inspect all the terminals in all three connectors for green corrosion, coolant or oil. Inspect all terminals regardless which DTCs may have set. Every terminal must be inspected since circuits that are corroded or contaminated can back feed into other circuits that are not corroded and set DTCs for associated systems.

Any terminal that has signs of green corrosion should be replaced with terminated leads. Do not clean the terminals. The contact area is difficult to clean and will lead to poor connections and intermittent DTCs. Solder all terminated leads and cover with

If the ECM terminals inside the ECM socket are corroded, the ECM must be replaced.
